USACERL Technical Report 98/34  
January 1998

# Seismic Mitigation for Equipment at Army Medical Centers

Methods Illustrated With Examples from Madigan Army Medical Center

by  
James Wilcoski

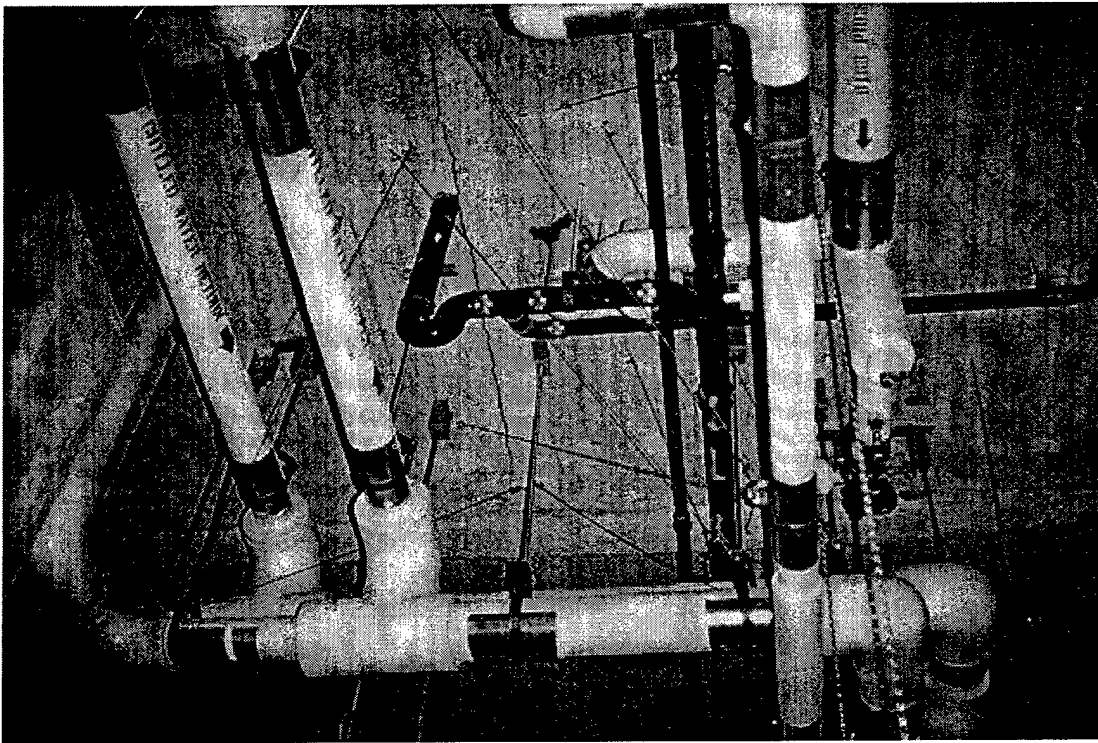
Figure 19 shows overhead suspended pipes in a mechanical room. These appear to be well suspended with tie rods and braced with cables. The cables carry tension only, so they must extend to the ceiling structure in all four directions (e.g., north, south, east, and west) in order to carry the seismically induced loads in both lateral directions. Overhead anchored equipment is supported through the ceiling by the interstitial floors. Figure 20 shows an overhead anchored telescopic arm supporting an x-ray head (collimator). The supporting rails appear to be well anchored to the overhead interstitial floor. Figure 21 is a view looking down at an interstitial floor showing a frame that distributes the load from overhead anchored equipment below to the interstitial floor. Based on the site visit it could not be determined what this frame is supporting, but it

Figure 19. Overhead suspended pipes in a mechanical room.

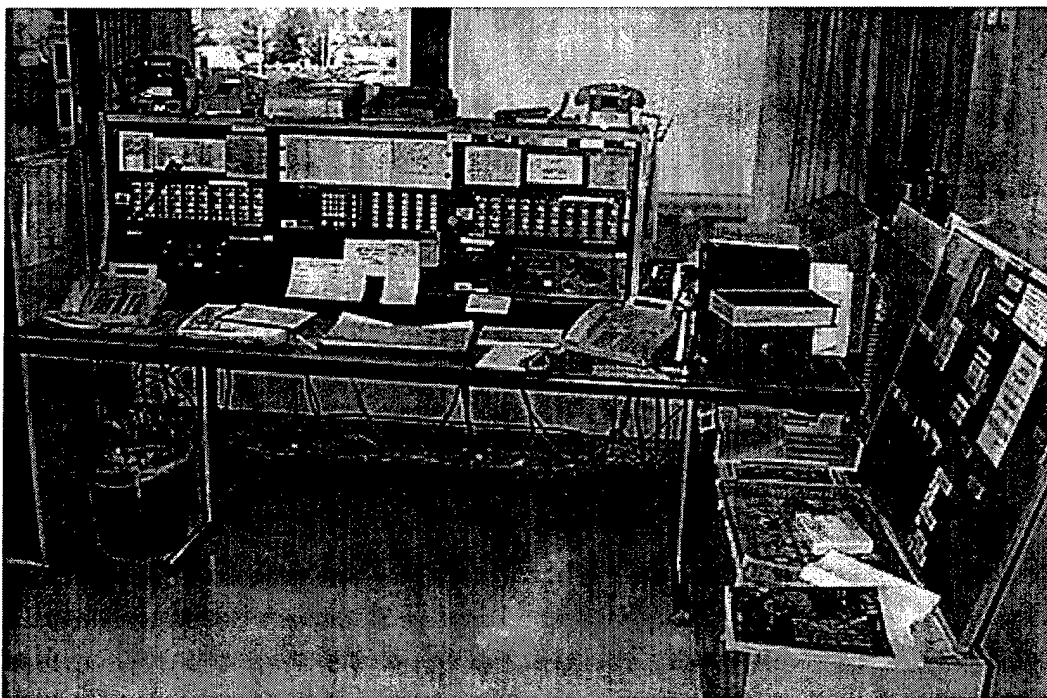
Figure 22 shows what may be the most urgent problem found at MAMC. Communications equipment at the emergency room communications center was resting loosely on a folding table, which in turn rests loosely on the floor. Figure 23 shows the edge of this equipment, which demonstrates how tall it is relative to its depth. According to the operators of this equipment, the supplier sent the wrong support cabinet. Apparently this unit was temporarily set loosely on the table, but the correct cabinet was never obtained or installed. In even a moderate earthquake the table would slide on the floor and the equipment would topple. The correct cabinet should be ordered as soon as possible. The communications equipment should be anchored to the cabinet and cabinet should be anchored to the floor. If this cannot be done immediately, the equipment should temporarily be anchored to a more stable counter. In this same room security monitors and fire detection units were well anchored, but the back of their cabinets were open. These cabinets should be closed to prevent the monitors from falling out backwards during an earthquake.

Figure 22. Equipment at emergency room communications center resting loosely on a table.

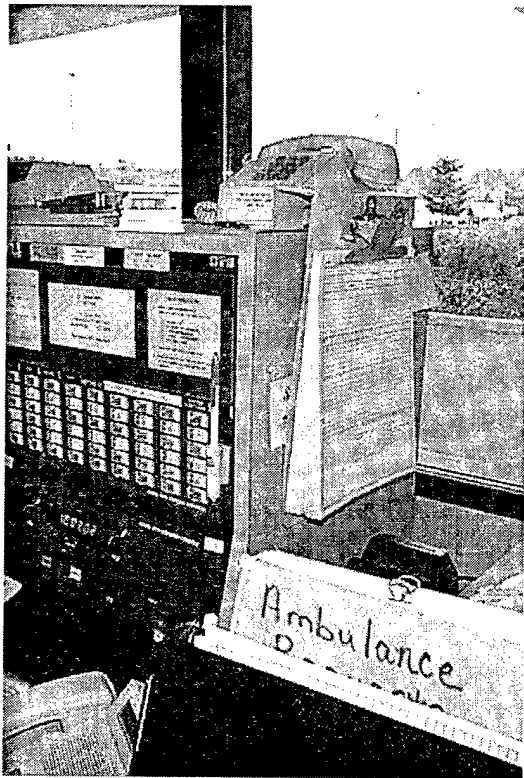
Figure 23. Side view of communications center equipment.

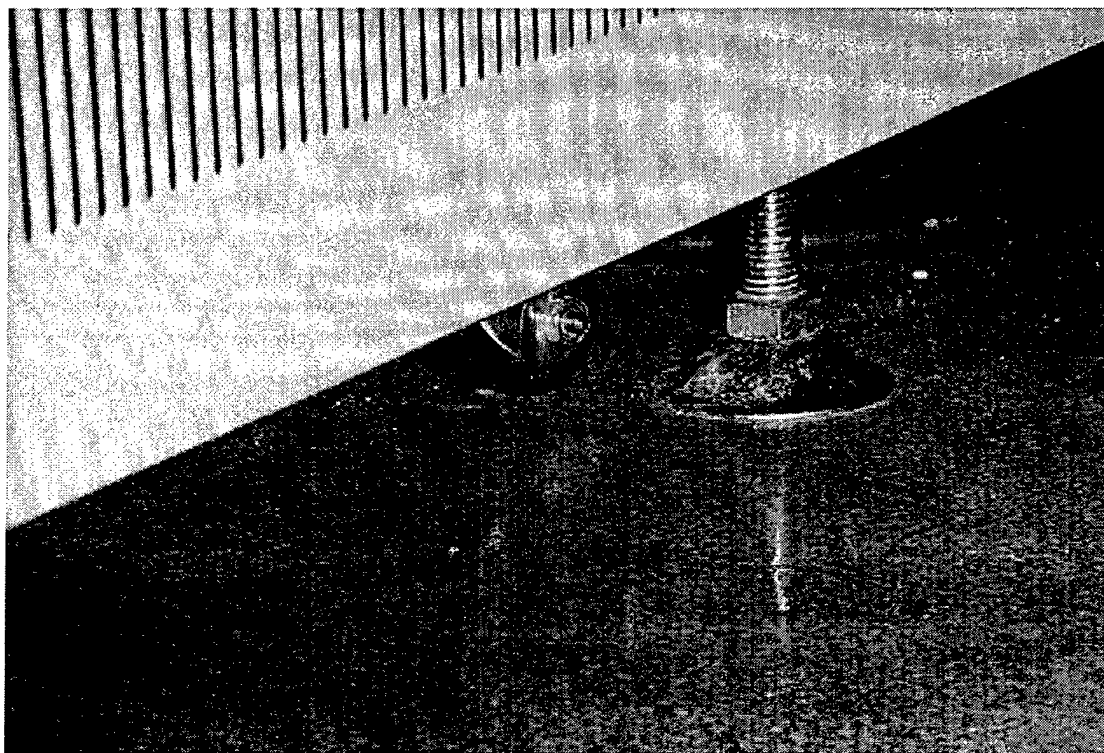
Figure 25. Close-up showing lack of anchorage for the Digiscan equipment.

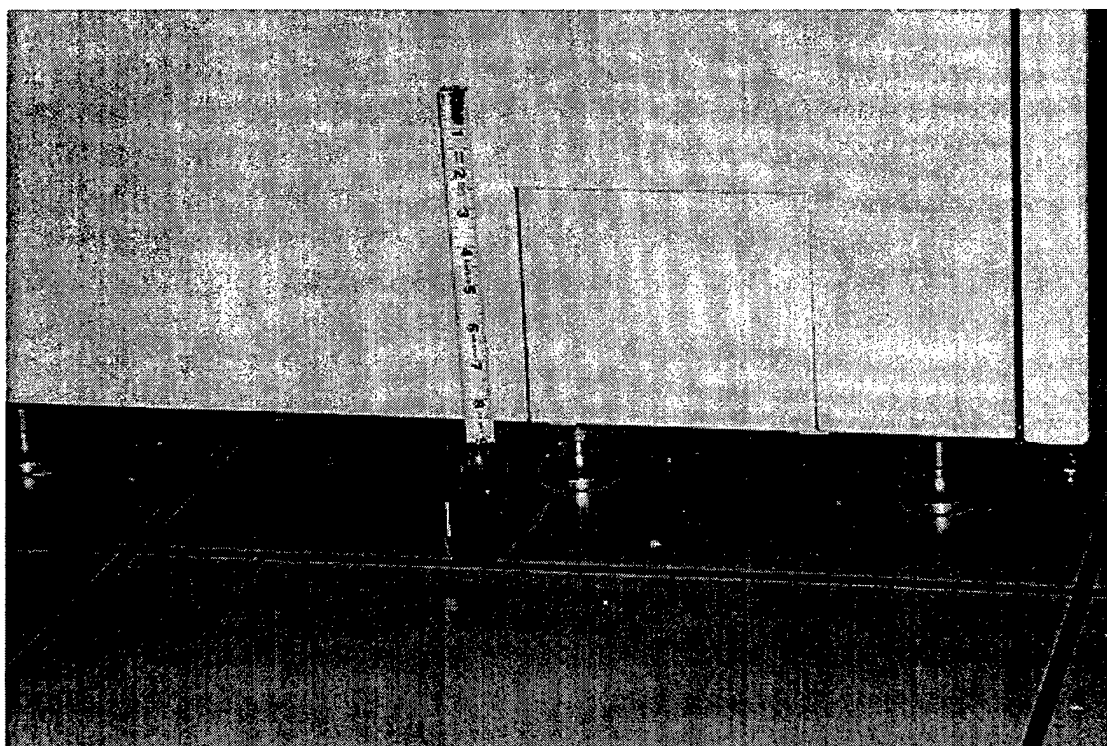
rests loosely on the computer floor (Figure 27) and is of critical importance to medical staff at MAMC. The supporting computer floor tiles are loosely supported on a stringer system frame. Computer floors supported on stringer system frames apparently perform well in earthquakes. Other computer floors are supported on a stringer-less system where a post supports and should be fastened to each corner of the floor tiles. These posts must be braced to resist lateral seismic motions. Often the fasteners are left out, and in earthquakes loose tiles near equipment could shift off their posts, and drop to the floor below. This in turn would allow equipment to shift and drop into the fallen tile area on one side, and then fall over. All critical equipment should either be bolted to the floor below the tile using a tie-rod or, for lighter equipment, bolted to individual floor tiles. Figure 28 shows a mainframe computer, supported on a computer floor that was tested on the USACERL Triaxial Earthquake and Shock Simulator (TESS). This was the standard field installation for seismic design where the tiles were fastened to the computer floor posts, the posts were braced, and the computer was fastened to the floor below using a tie-rod that penetrated the computer floor surface. This configuration performed well in seismic qualification tests.<sup>3</sup>

Figure 27. Close-up showing lack of anchorage for the optical disk system.

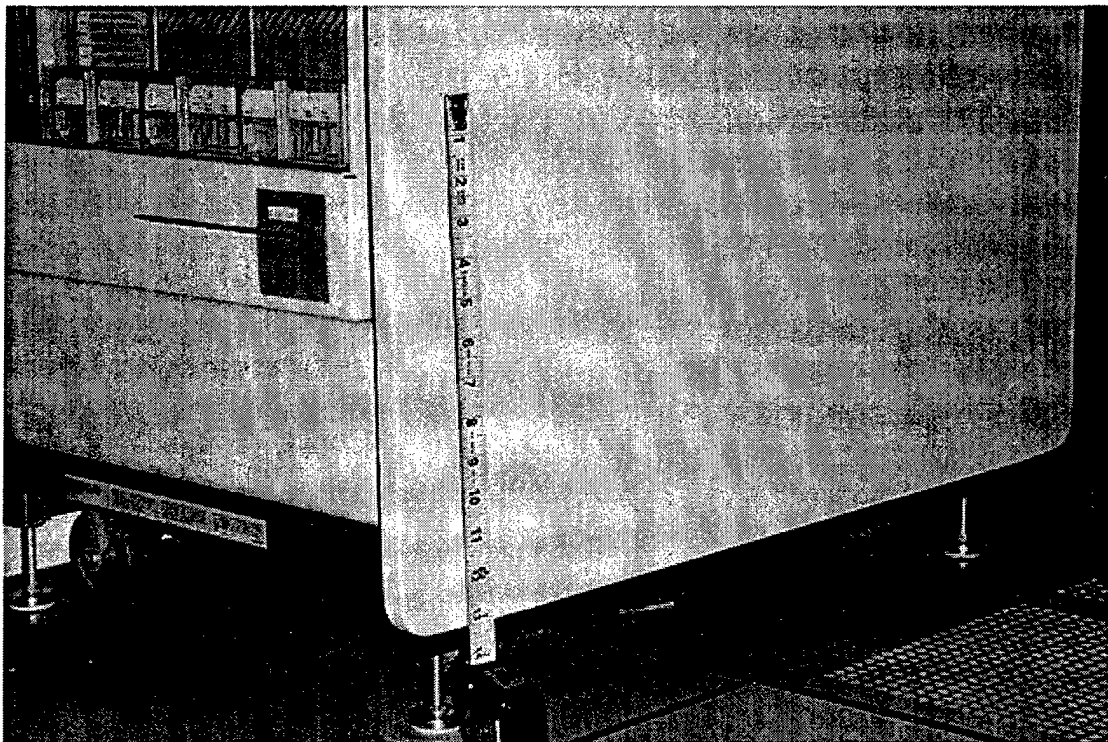
Figure 30. Close-up showing a lack of anchorage for the mini-computer.

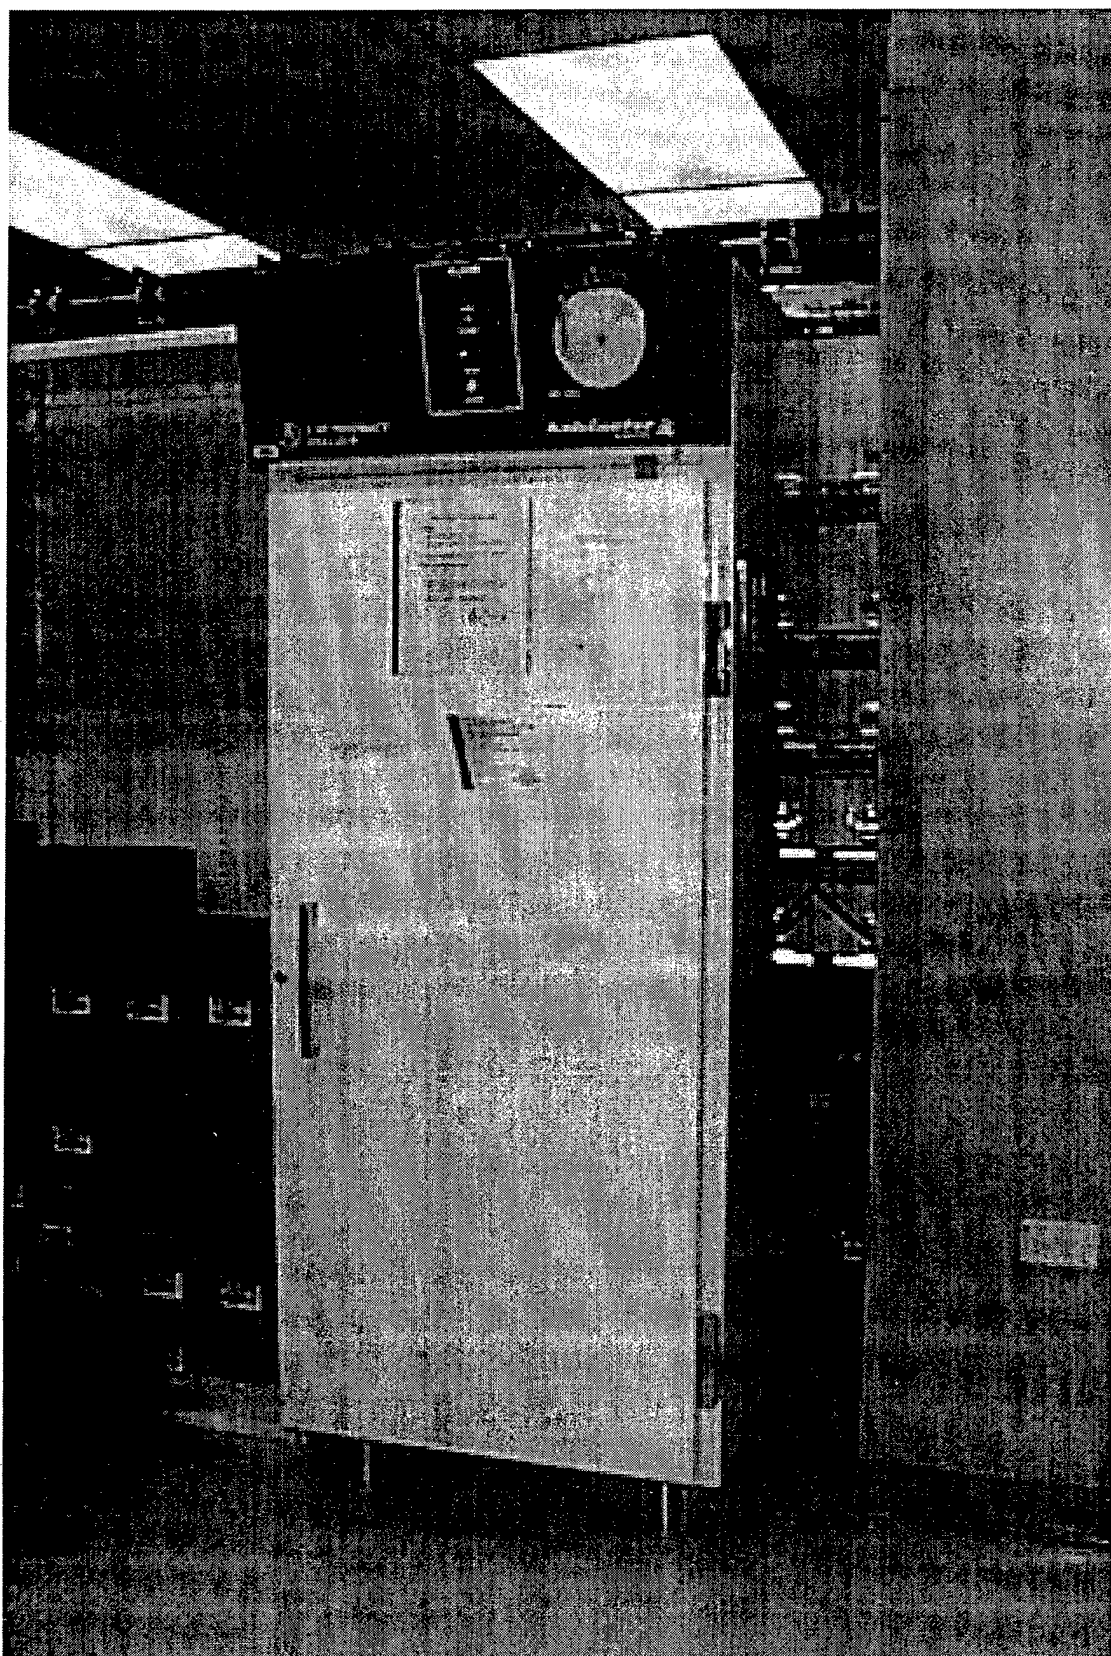
pharmacy freezer that is quite tall, has a small footprint, and is unanchored. (It should be noted that the kitchen also has many tall, narrow unanchored coolers and freezers similar to this.) These should either be braced (see Figures 4 and 14) or anchored to the floor. Figures 34 and 35 show tall, narrow shelves. These shelves can be simply braced by bolting them to a wall or to each other in a T or L configuration (in plan). The two shelves shown in Figure 34 could be braced by simply bolting them to each other near their tops and bottoms. (They will form a T configuration in plan if left in the positions shown in this figure.) Tall shelves such as those shown in Figures 34 and 35 could also be braced to the ceiling structural system. Shelves that are at least seven feet tall configured in parallel rows can be braced to each other perpendicular to the row and across the tops. Figure 36 shows small storage bins in the pharmacy. These bins have a small lip at the front. Storage bins like these should have a higher retainer edge to keep contents in the bins. The same retainer edge should be used for horizontal shelves throughout MAMC. It is recognized that such a retainer edge would make shelves slightly less accessible, but this is a relatively small cost to protect important medical assets. This approach is used in other types of facilities in active seismic regions, such as libraries in California which often have wires in front of books to hold them in place during an earthquake. Lightweight contents can also be held on shelves with cabinet doors with latches.

Figure 33. Tall unanchored pharmacy freezer with a narrow footprint.

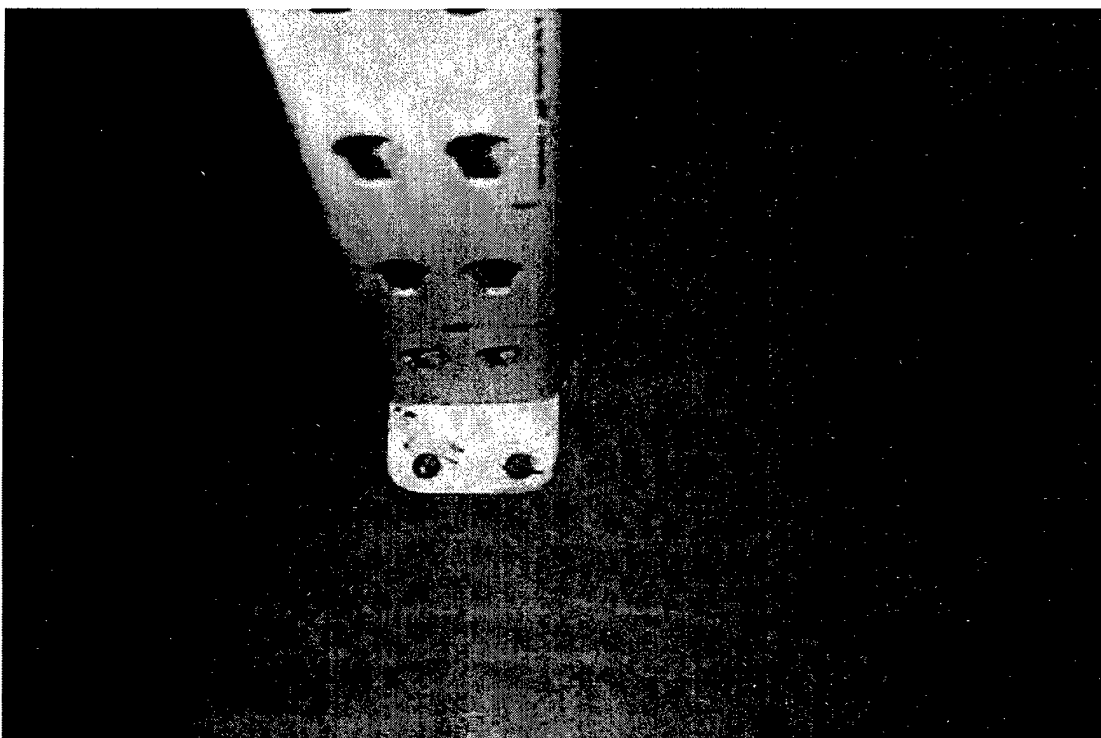
Figure 38. Close-up of logistics area storage racks showing lack of anchorage.

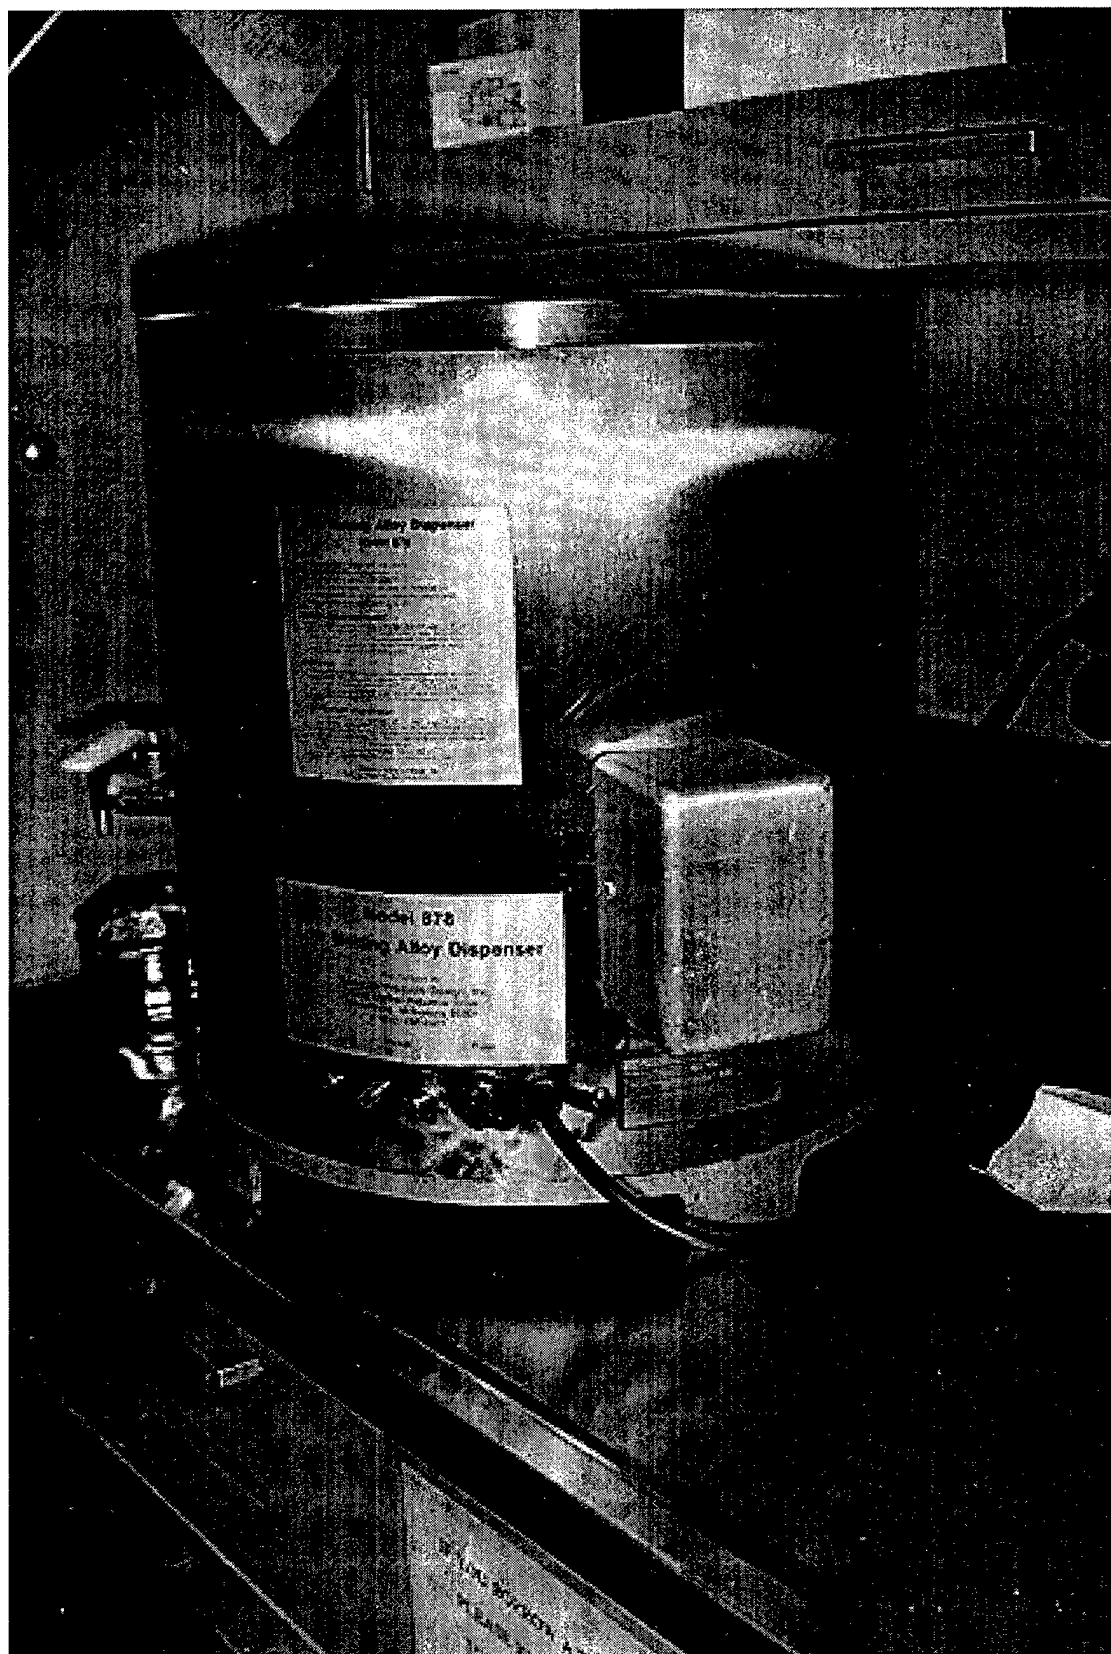
machine can easily be bolted to the floor. Figure 42 is a low-melting alloy dispenser, providing molten lead for casting radiation shielding blocks. This unit weighs over 100 lb (45 kg), and is resting loosely on the countertop. It should be anchored to the countertop or braced back to the wall. Figure 43 shows typical laboratory equipment — both the cabinet and its contents should be anchored. Also note the file cabinet on the right side of this figure — it is unanchored and may easily topple, blocking escape from the door next to it.

Figure 42. Low-melting alloy dispenser, shown resting loosely on countertop.

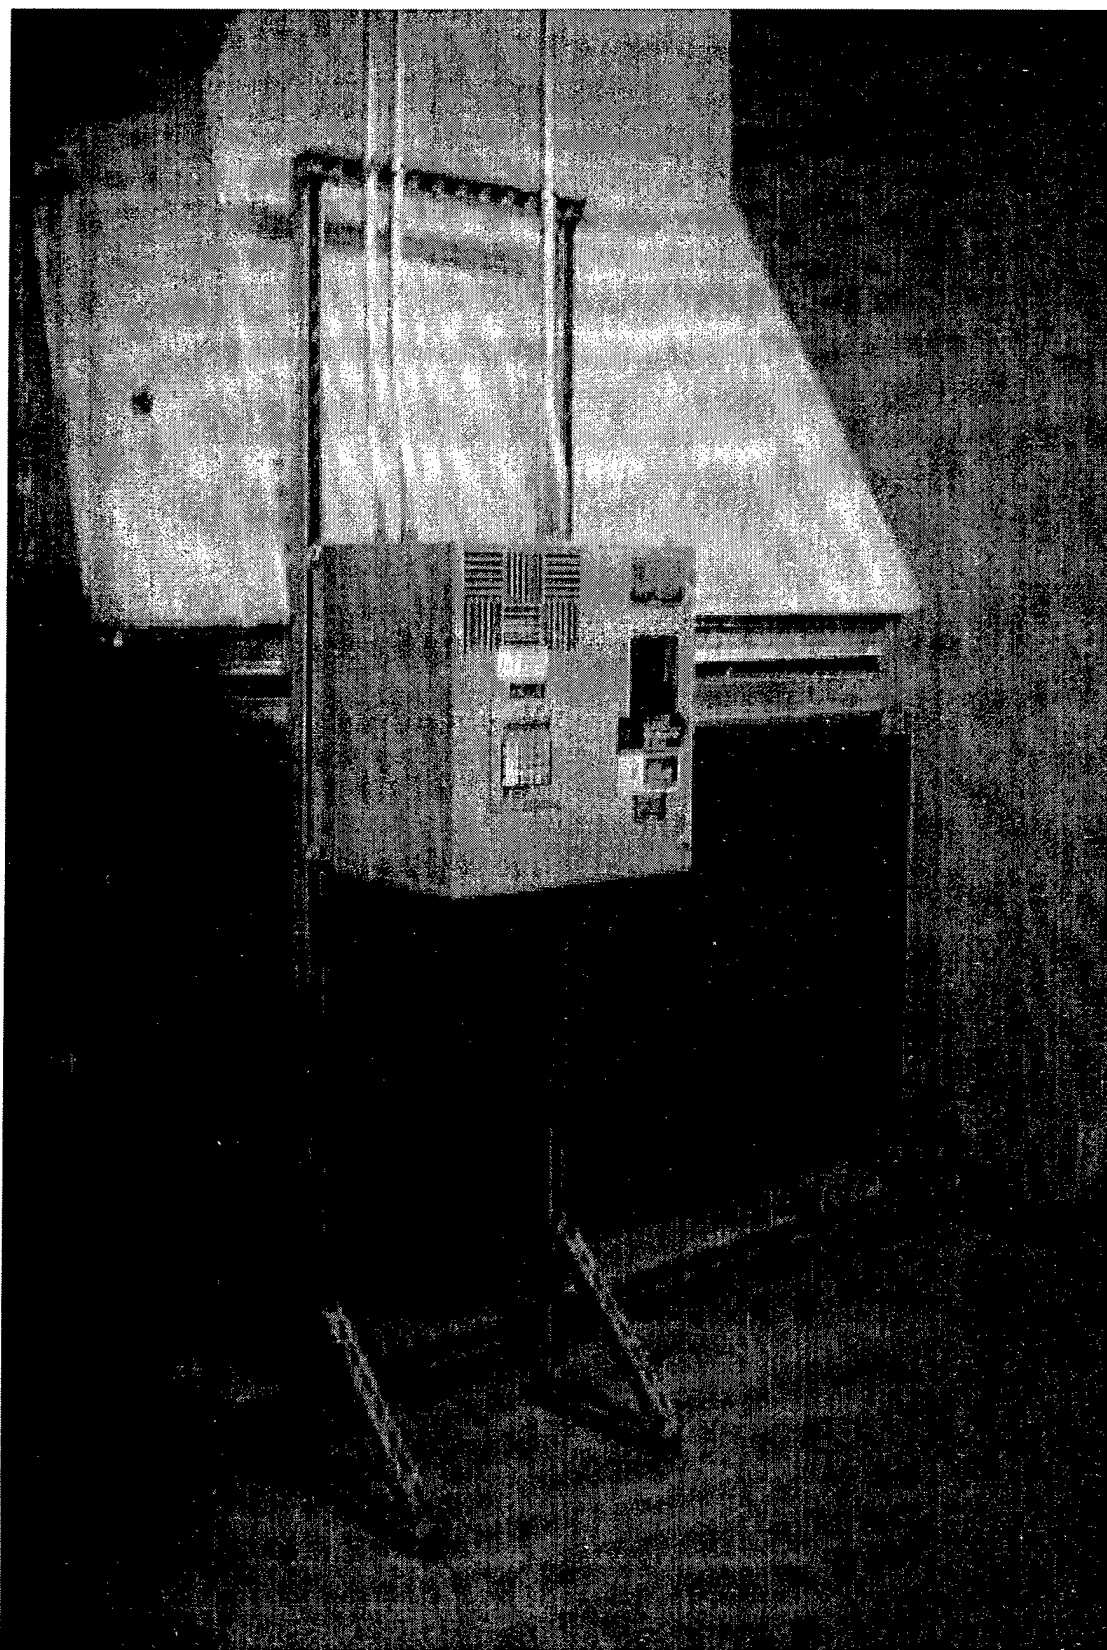
Friction clips, which are often used to support or brace cable trays and various other equipment, should be avoided. Figure 46 shows a Unistrut frame supporting an air-handling unit control panel in a mechanical room. The brace at the bottom of this frame uses friction clips to connect the diagonal members. These clips may work loose after several cycles of seismically induced motions. Such connections should be made with standard fasteners rather than these clips.

Figure 46. Unistrut frame with friction clips supporting air handling unit control panel.

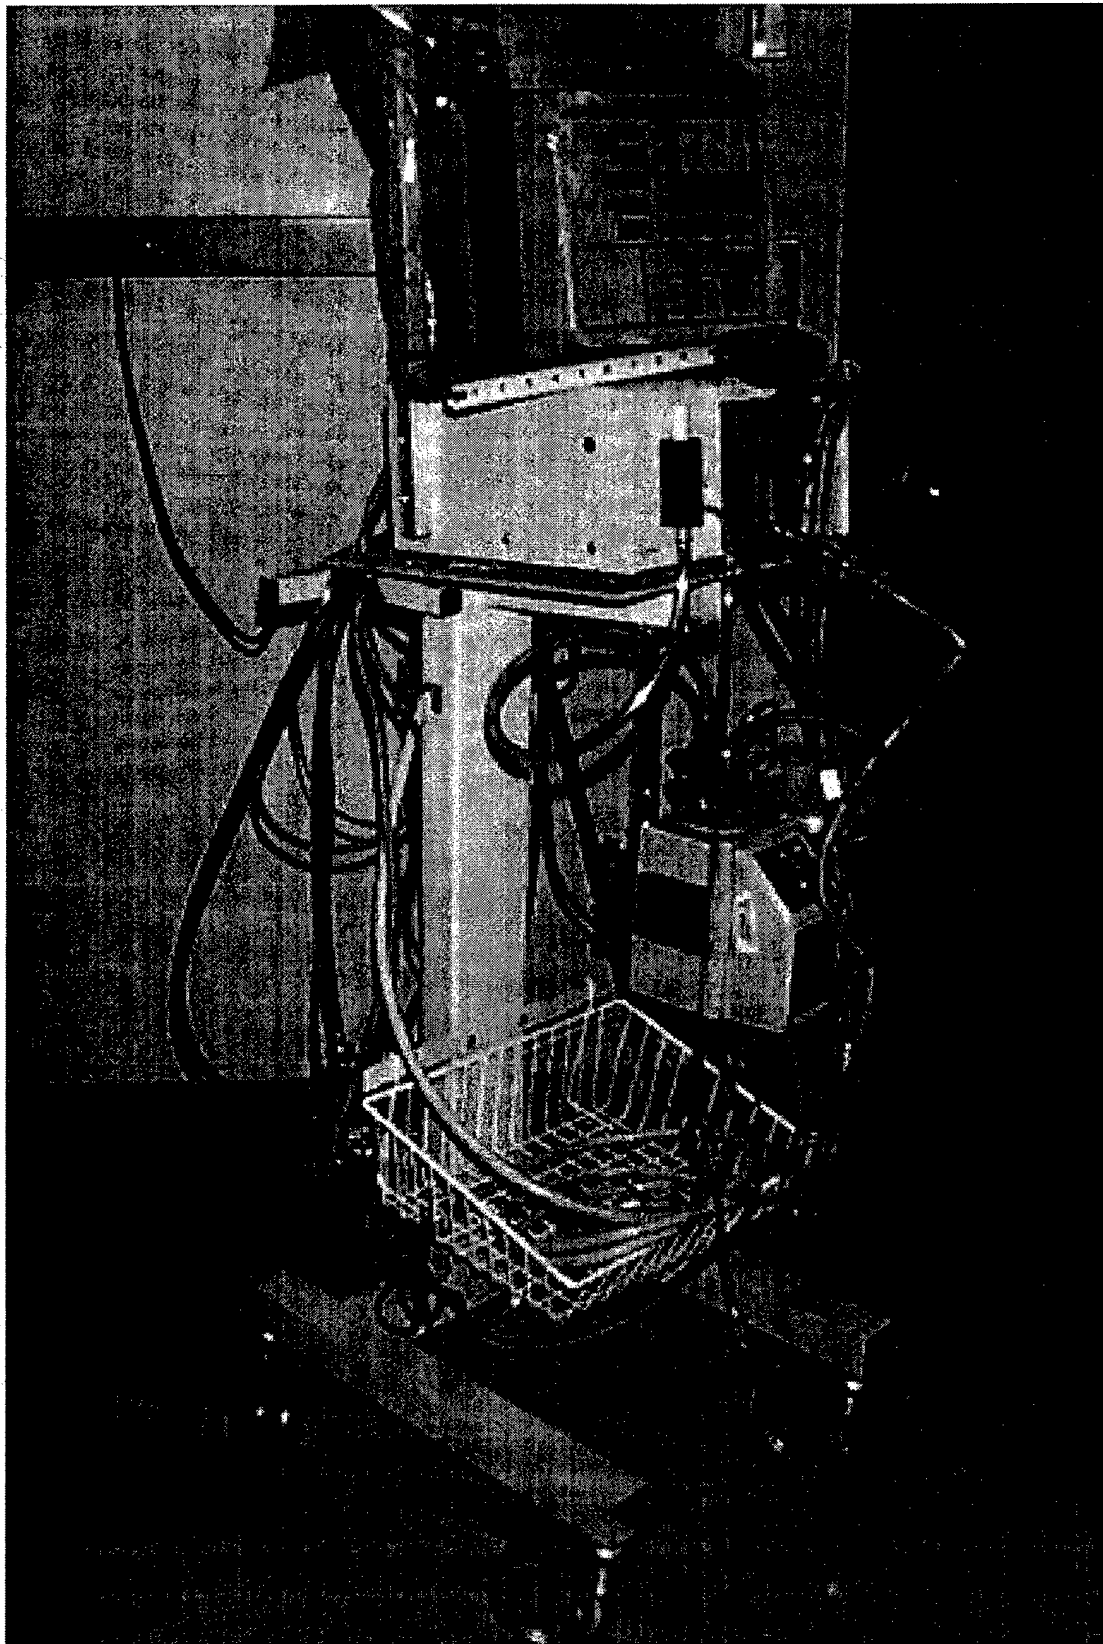
impact may damage either the equipment on wheels or whatever it hits, such as gas lines in intensive care units. It is recommended that the wheels on all such equipment be kept locked. Even with the wheels locked this equipment may fall over if the wheelbase is not wide enough relative to the height of the equipment center of gravity. If such equipment cannot be anchored, it can only be protected by increasing the wheelbase or lowering the center of gravity. Equipment on rollers was seen in the emergency room communications center, intensive care unit (ICU) rooms, ICU nursery, delivery rooms, operating rooms, and in the area near gamma ray cameras. Figure 47 shows a nursery bed on wheels in the ICU nursery. Figure 48 shows a monitor on wheels with a very narrow wheelbase. Figure 49 shows other equipment with a narrow wheelbase near the ICU nursery.

Figure 49. Other equipment on wheels with a narrow wheelbase.

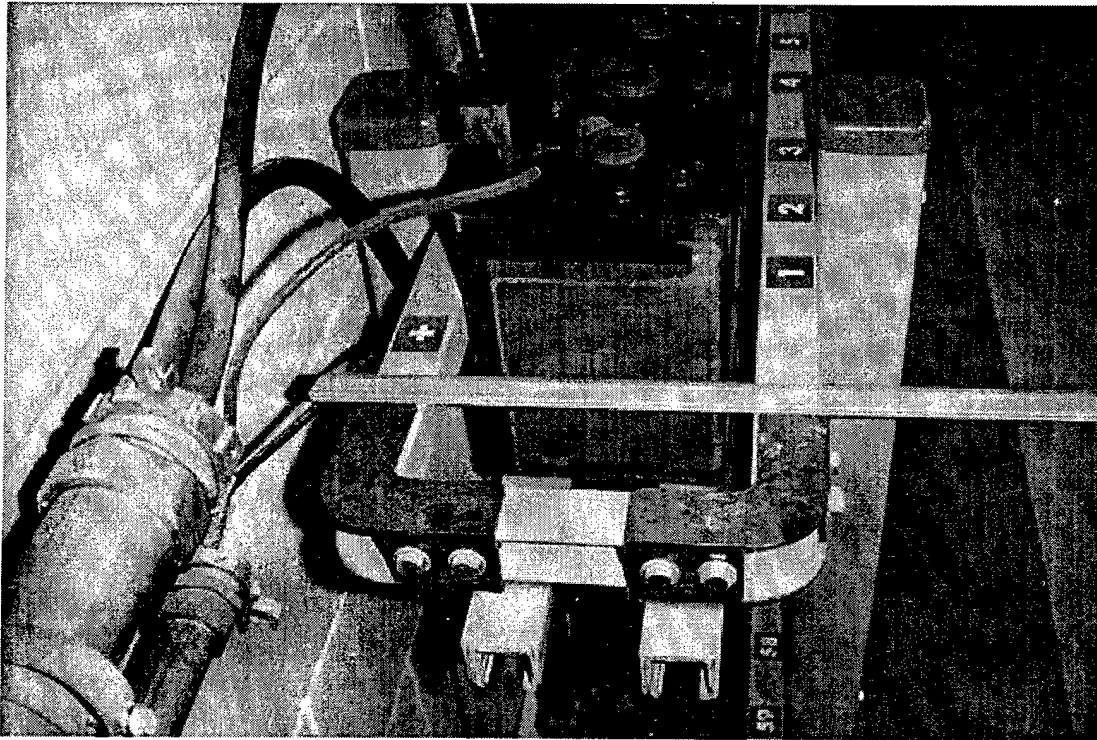
Figure 50. Close-up of station batteries showing lack of foam spacers.

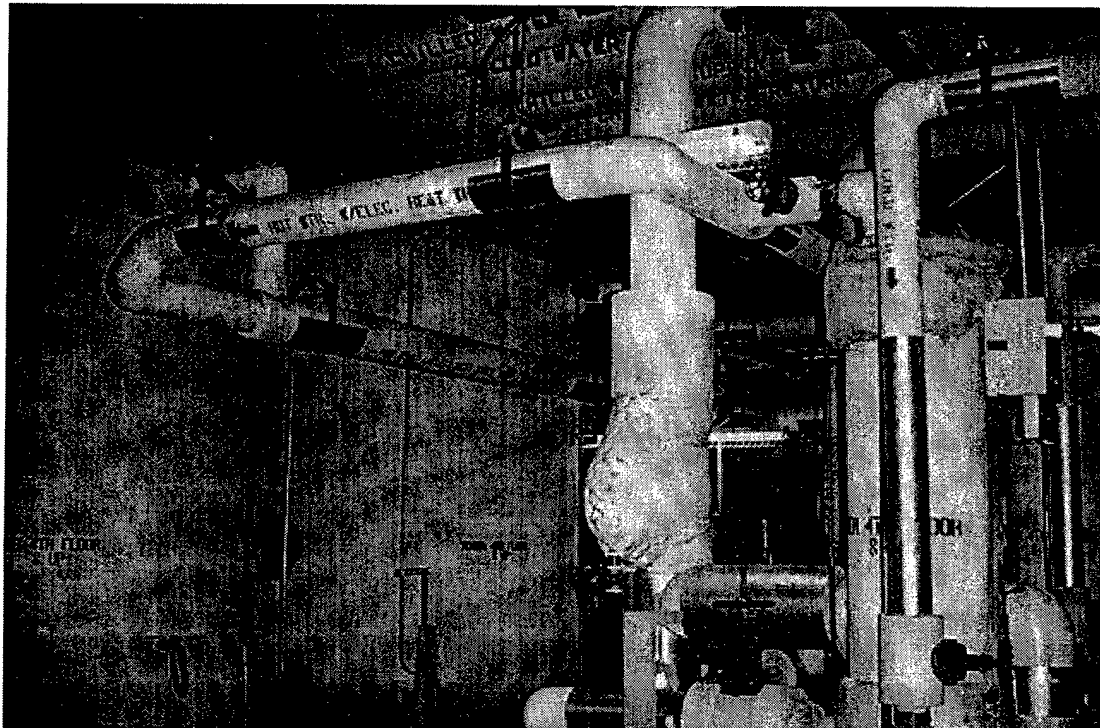
On the left-hand edge of Figure 51 a large hot water tank can be seen. A 4 in. (10 cm) pipe (approximate) connected near the top of this tank couples it to a much smaller tank near the right edge of Figure 51. The pipe is primarily horizontal near the top of photograph in Figure 51. This coupling pipe may cause a problem by not allowing differential movement because it will be very rigid along its axis. In an earthquake the larger tank will oscillate at its own natural frequency, with relatively large displacements near its top. The connecting pipe will then drive the top of the second tank, in the direction of the pipe's axis, with the same motion as the top of the first tank. However, this motion will have a different frequency, phase, and amplitude than the natural motion of the smaller tank. It is important to determine whether the supports for the smaller tank can handle the displacements and forces placed upon them, and whether the pipe connections can withstand the forces placed upon them. Determining the answer to this seismically induced forced vibration problem would require further study. However, this example does demonstrate the potential problems created by the elimination of differential movement when equipment is coupled together.

Figure 51. Large hot water tank coupled to smaller tank, restraining differential motion.

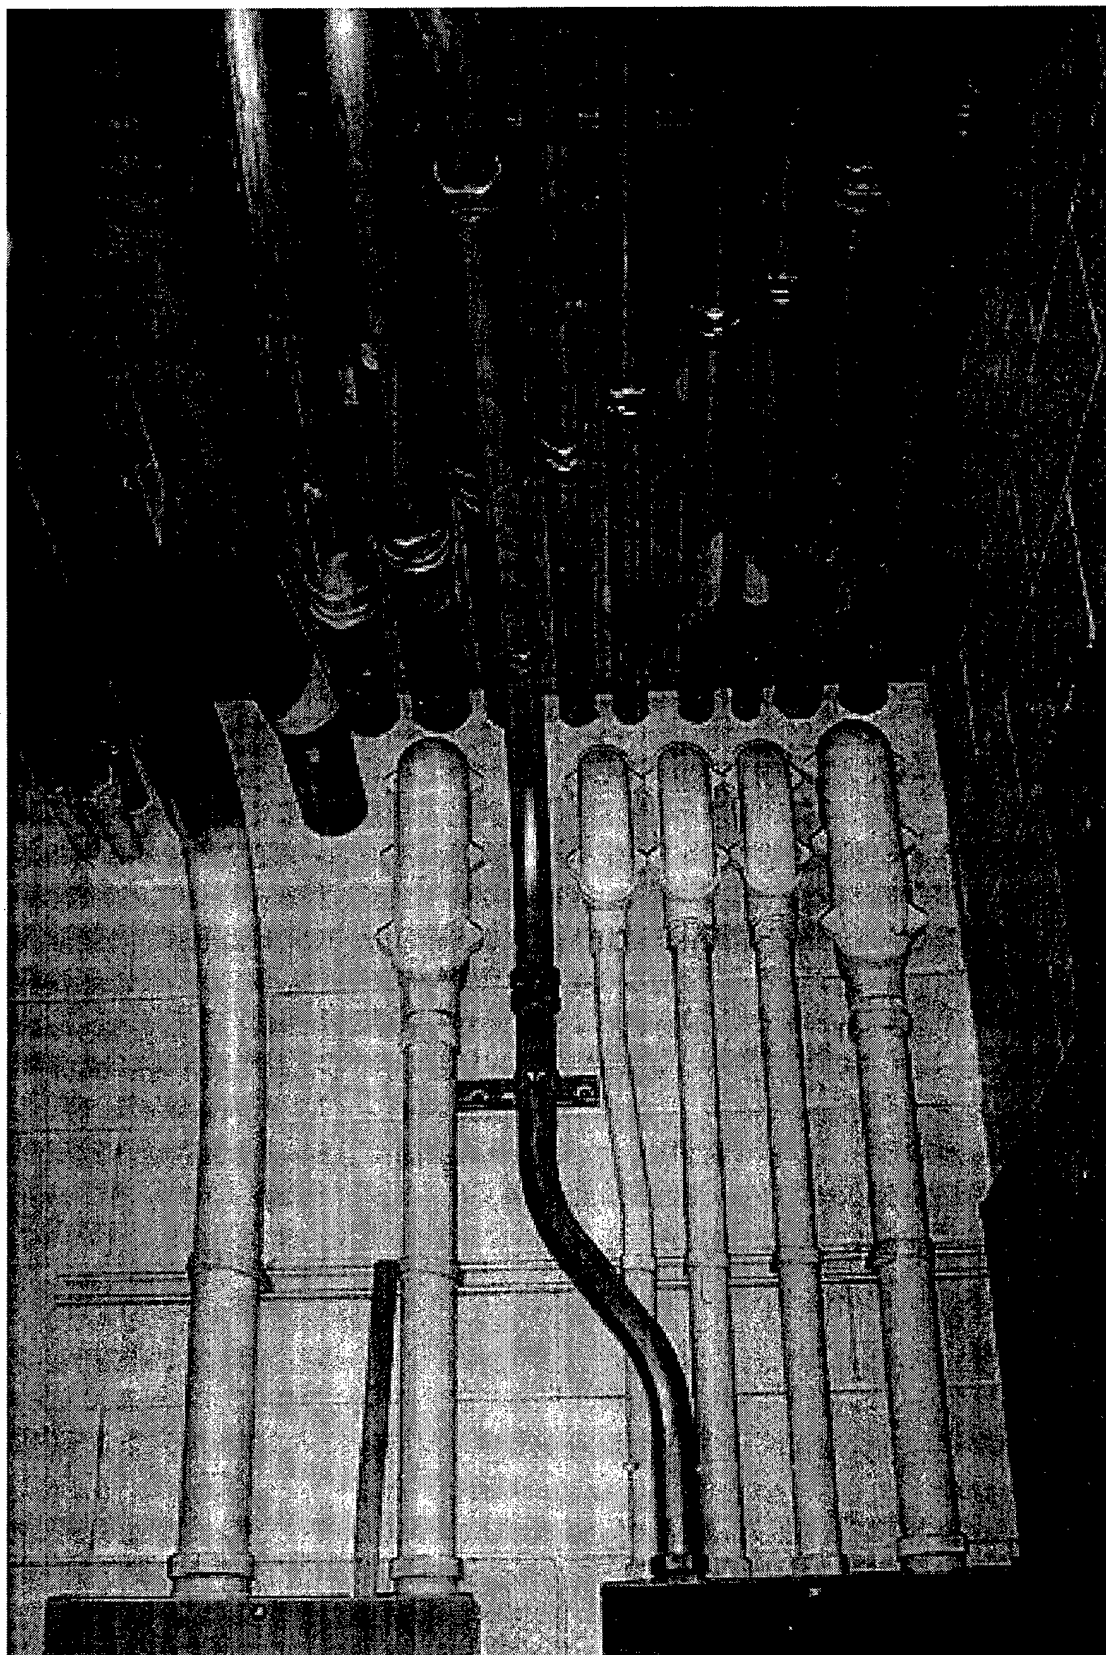
Figure 52. Heavy conduit penetrating CMU wall, loading wall out-of-plane.

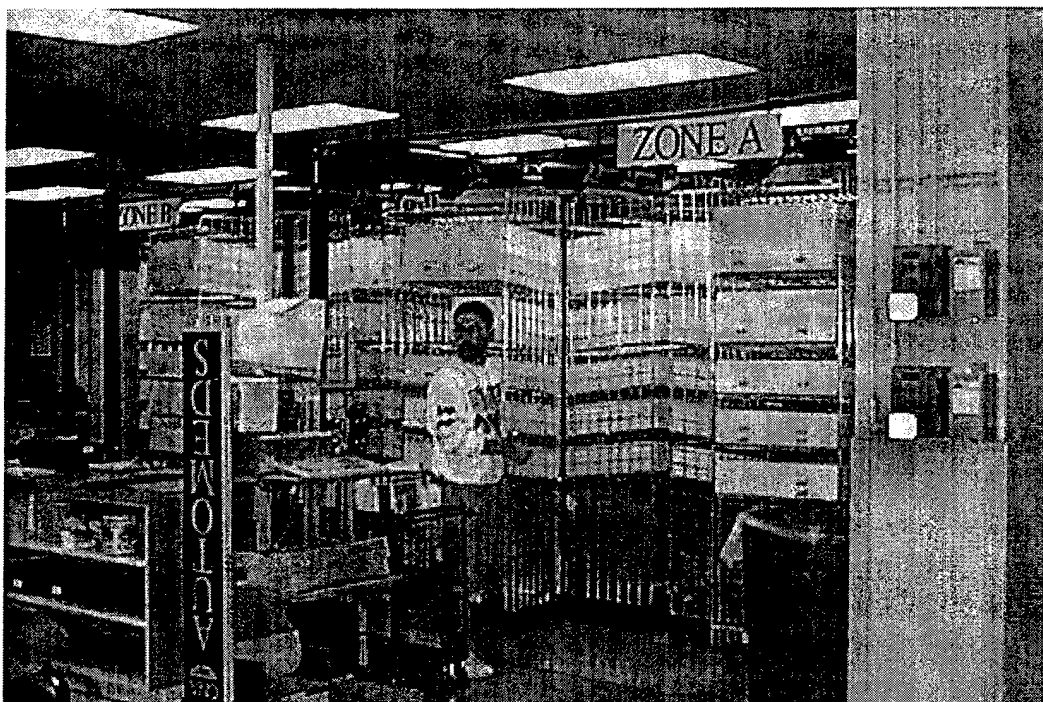
The outpatient pharmacy is supplied by the automated storage racks shown in Figure 53. These movable racks provide 10 days of supply storage. The racks are supported with a structural floor and frame designed to carry 1000 lb (453kg) per 2 x 2 ft (in plan) and 7 ft tall (0.6 x 0.6 x 2.1 m) unit. According to MAMC personnel responsible for this area, the actual weight per unit rarely exceeds 200 lb (90 kg). The logistics area has similar storage racks; their contents appear somewhat heavier, but still well within frame capacity. These frames are approximately 60 ft deep (front to back) and move clockwise along a horizontal track in such a way that racks on the right move toward the front while racks on the left move toward the rear. Therefore, one frame supports about 120 linear feet of 2 x 2 x 7 ft storage units. The pharmacy is equipped with five of these frames. The frames are well anchored to the floor and they appear to be well braced to carry seismically induced lateral loads. The storage units appear to be well supported, with all vertical loads carried along a track at the tops of the frames. The bottoms of these units are restrained by a roller from swinging in against a support bar on the frame, but they are free to swing out — particularly away from the track ends. The racks of one frame are separated from the racks of the parallel frame by only 6 in. Figure 54 shows the bottoms of the racks of two such frames, with the 6 in. separation seen in the center of the photo. In the center of this photo a box has been laid to span across between the two frames. In an earthquake, these frames will be free to swing out at their bottoms, striking the adjacent racks. Immediately after an earthquake begins the racks should be shut down so this impacting will not bind the racks to each other. However, rack contents such as the box shown in Figure 54 will probably fall out of the racks, or to an adjacent rack, or get wedged

between the racks, preventing the operation of the racks temporarily. This debris would need to be cleared away by manually removing rack units, climbing into the racks and removing the obstruction. It may require several hours to clear away the debris but should not cause a long-term problem. If someone attempts to operate the racks before removing this debris, the racks could be forced out of position and bind to each other. If this happened, the rack units or frames could twist, resulting in the need for time-consuming repairs. Therefore, after an earthquake, the racks should be inspected and debris removed to prevent longer-term problems. Figure 54 shows that the base of each rack section slopes in toward the center of the frame, which would help to retain most contents during an earthquake. The actual loss of rack contents should be minimal.

Figure 53. Front view of automated storage racks in the outpatient pharmacy.

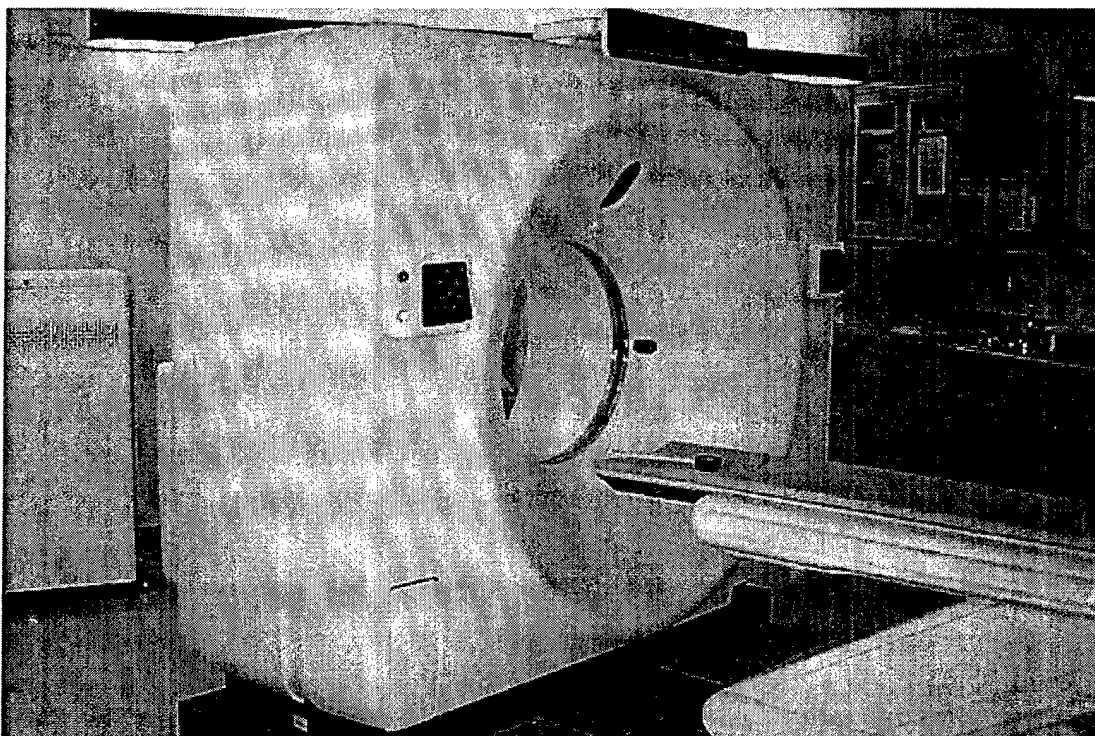
Figure 55 shows a General Electric (GE) computed tomography (CT) scanner. According to medical staff at MAMC, the x-ray tube and detector array rotate in the circular ring shown in Figure 55. These can easily move out of alignment during a seismic event — particularly while spinning. The CT scanner may be the most vulnerable medical equipment at MAMC and, as noted previously, is of particular concern to medical staff.

Figure 55. General Electric CT Scanner, potentially the most vulnerable equipment at MAMC.

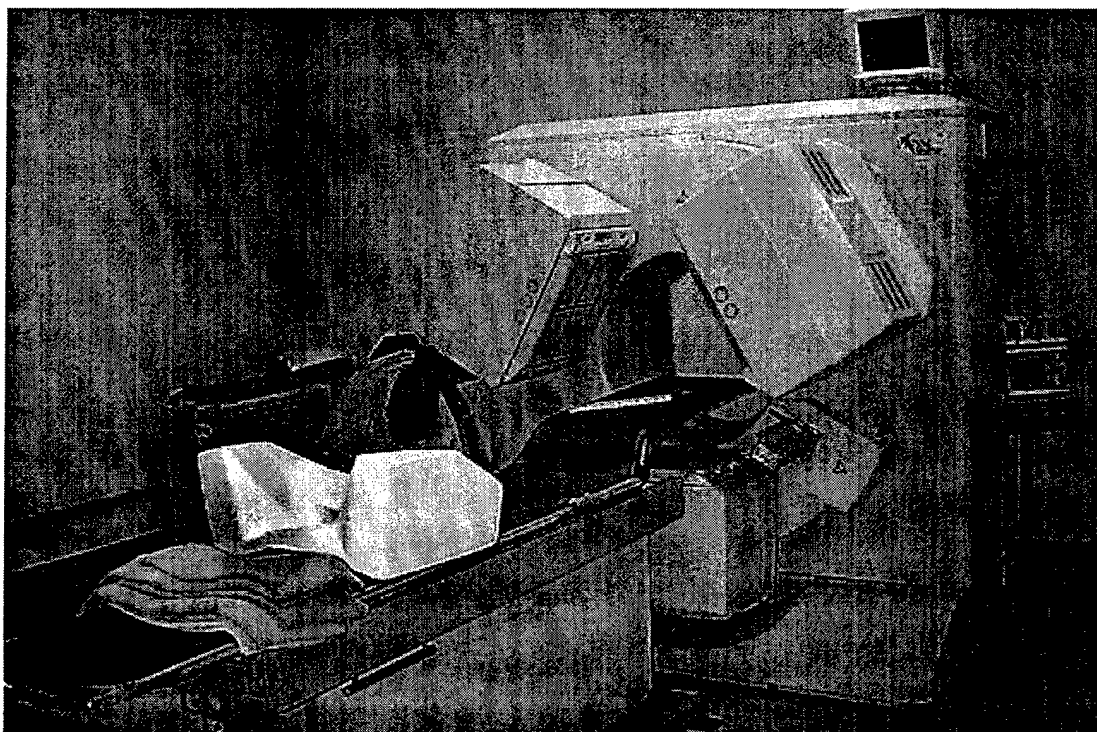
Gamma ray cameras of various types, all manufactured by Siemens, were seen at MAMC. These include the single-head Orbiter, a single-square-head Diacam, and a triple-head Prism 3000 gamma camera. The triple-head camera is shown in Figure 56. Each head in this camera contains 60 glass tubes in rows, costing \$3000 per tube. USACERL inspected the Sepulveda Veterans Administration (VA) Medical Center, which is located about 20 miles (32 km), Northwest of downtown Los Angeles, CA, shortly after the 1994 Northridge Earthquake. Figure 57 shows a single-head gamma camera that was damaged in the Northridge event. The camera was well anchored to the floor, but the mechanism at the base of the cantilever arm supporting the head was damaged.

Figure 56. Triple-head Prism 3000 Gamma Camera.
